BEFORE THE STATE OF MAINE PUBLIC UTILITIES COMMISSION

Docket No. 2019-00015

COMMISSION INITIATED INVESTIGATION OF METERING  
AND BILLING ISSUES PERTAINING TO CENTRAL MAINE  
POWER COMPANY.

Direct Testimony of

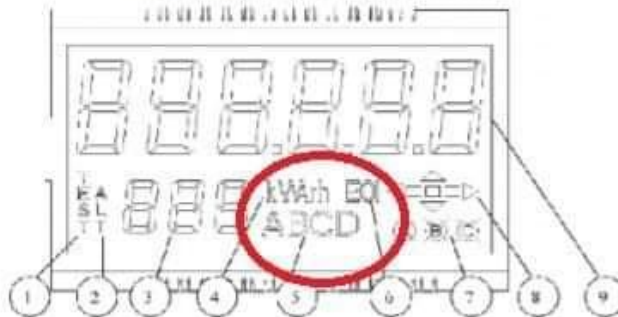
**Figure 5.1.A**

The Company should have known when each meter test was performed if the meters were operating in the default meter mode or “fast clock” by simply looking at the meter. In **Figure 5.1.A**, I circled in red the display for TOU or Time Of Use Rates. Seeing the A, B, C, or D means the meter is not operating as a totalizing (kWh) meter but as a default demand meter and needs to be reset. On **Figure 5.1.B**, I’ve circled on my own meter showing a TOU rate B.
